RICS Home Surveys

**Survey level two:
HomeBuyer report
-
Survey**

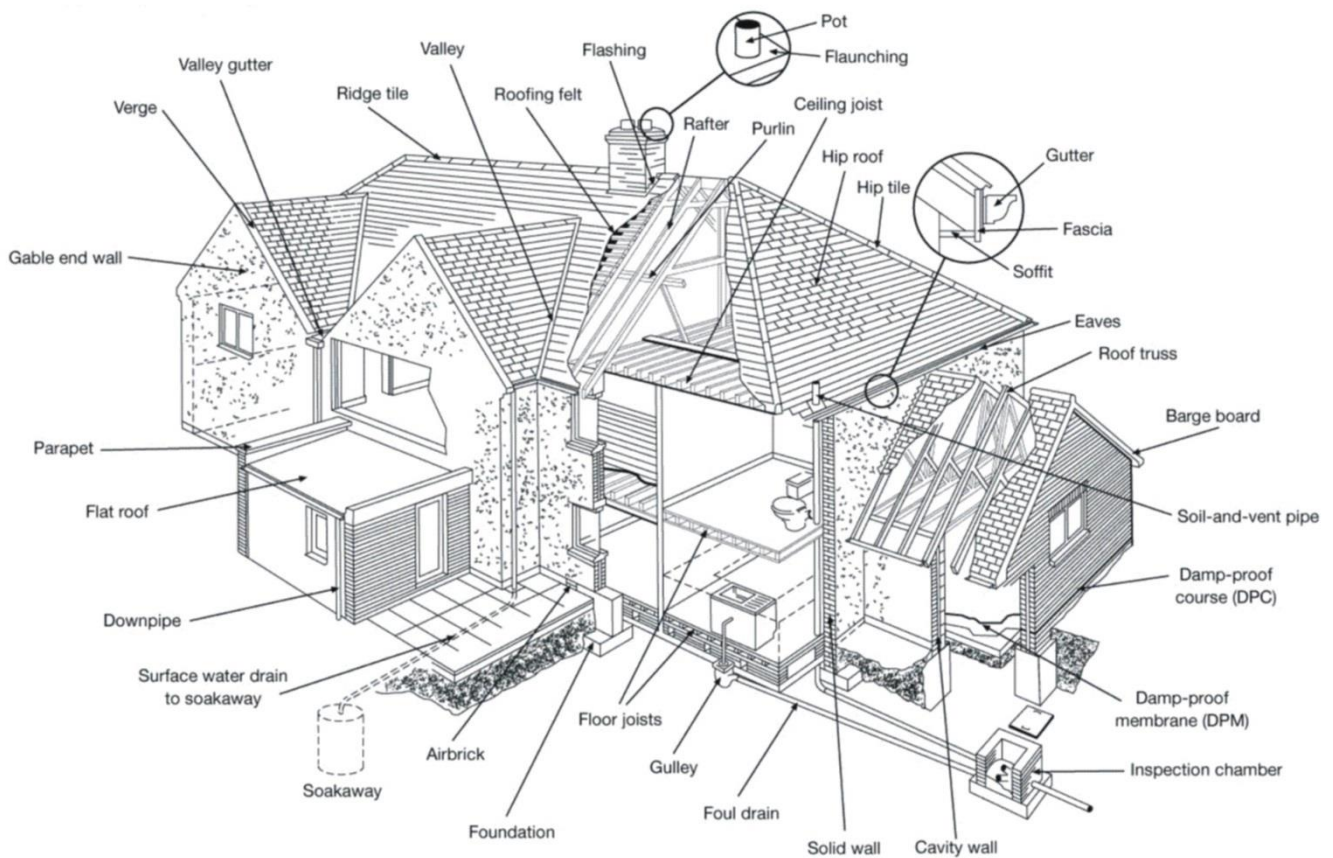
Typical house diagram

This diagram illustrates where you may find some of the building elements referred to in the report.
