RICS Home Surveys

# Survey level two: HomeBuyer report - Survey

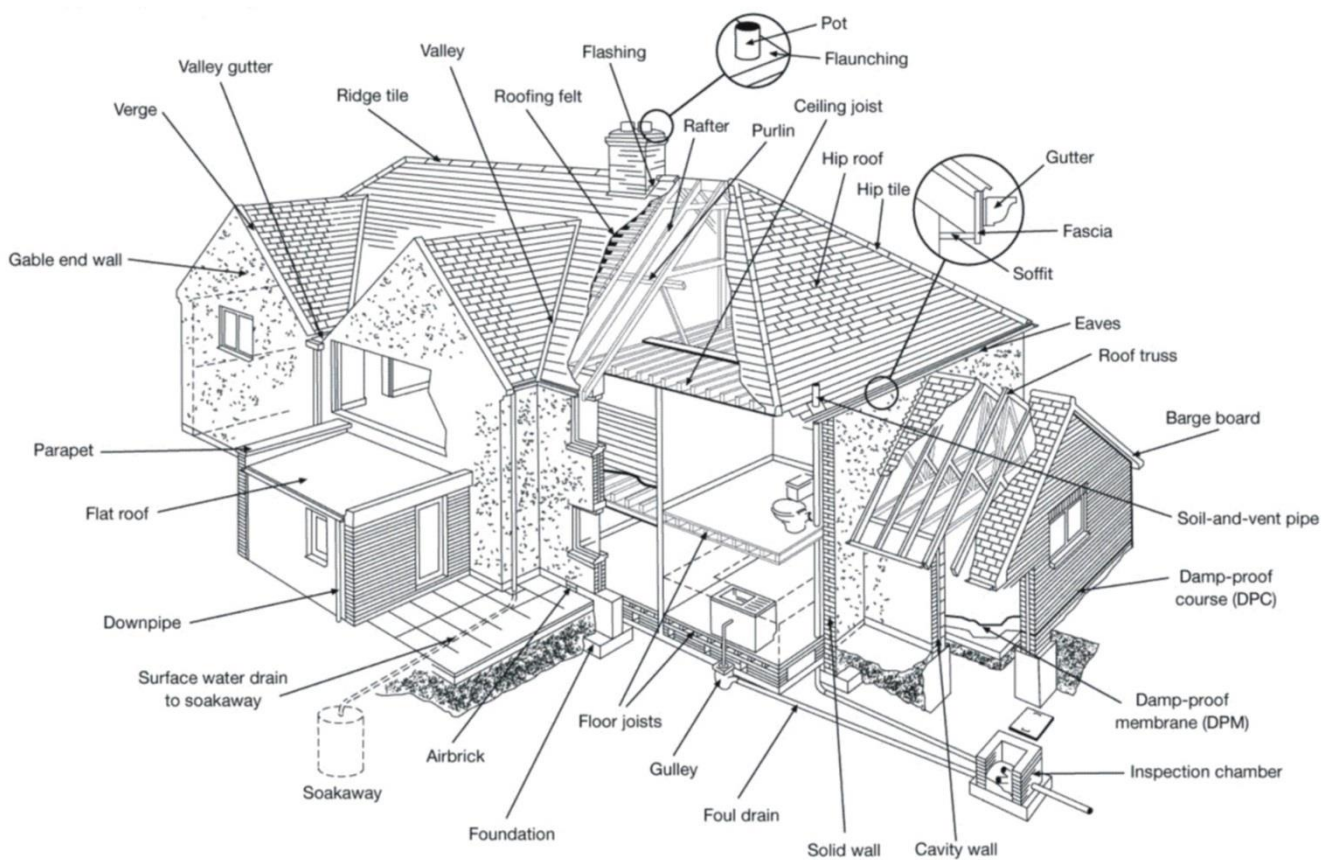
# Typical house diagram

This diagram illustrates where you may find some of the building elements referred to in the report.
